Case Study – School Stockton-on-Tees 2016

Background

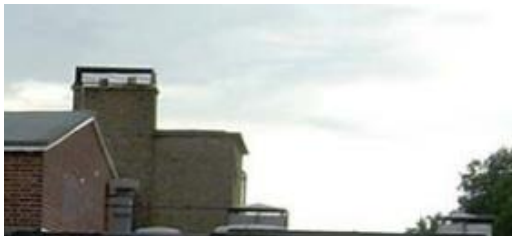
The water tanks were situated at the top of a brick tower some 15 meters high with an old steel access ladder for access. It soon became apparent that these had not been inspected, the School had been told they had been.

Tanks in a roof tower

Watercare provided specialist staff with harness and confined access training to carry out this work.

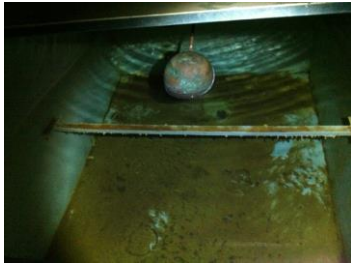
Our staff had been told that the tanks had been inspected, however our assessor requested a new inspection. The tanks were found to be filthy and full of debris.

We initially cleaned out and chlorinated the storage tanks, then we returned and re-lined the storage tanks leaving them clean and hygienic.
